U.S. DEPARTMENT OF AGRICULTURE

PHOTO SERIES NO. 17

STORING CORN FOR THE LONG HAUL

SEPTEMBER 1958

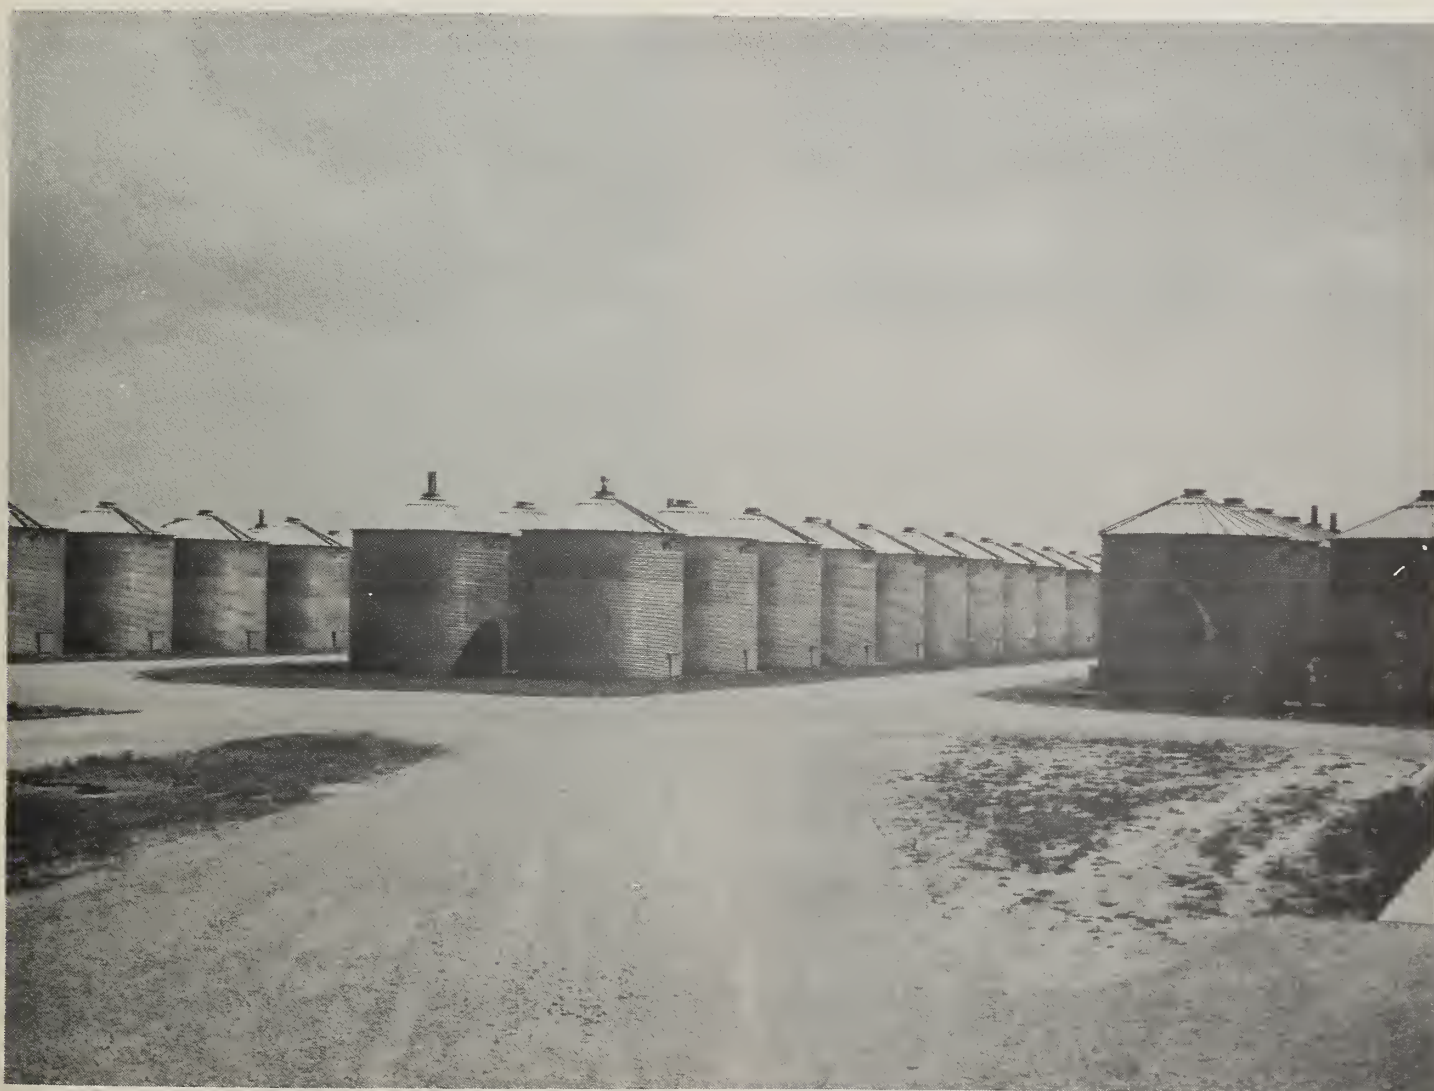
N-25762--At the corn storage research project, near Watseka, Illinois, 210 metal bins filled with 3,000 bushels each of shelled corn are used to study long-term storage problems. Most of the bins are divided into groups to study temperatures, chemical treatments, insects, moisture, etc.

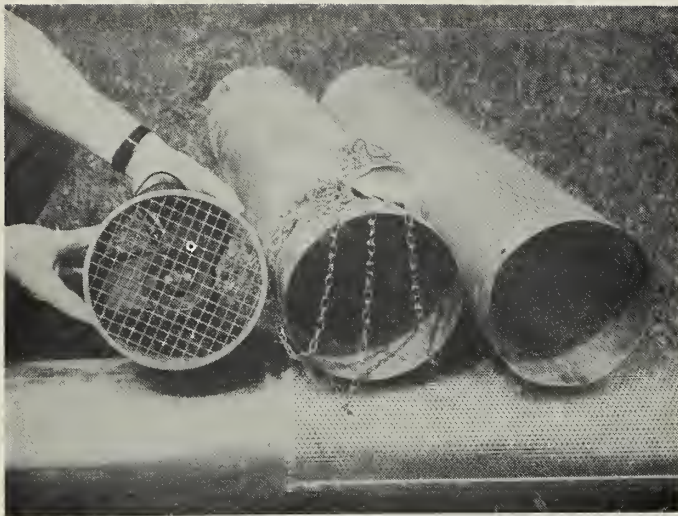
N-25763--A satisfactory way of moving air through grain in a bin is by means of a vertical duct with a small electric fan at the top. The fan pulls air down through the grain into perforated sections of the duct, and exhausts it through the top. A motor of 1/80 horsepower operates the fan.

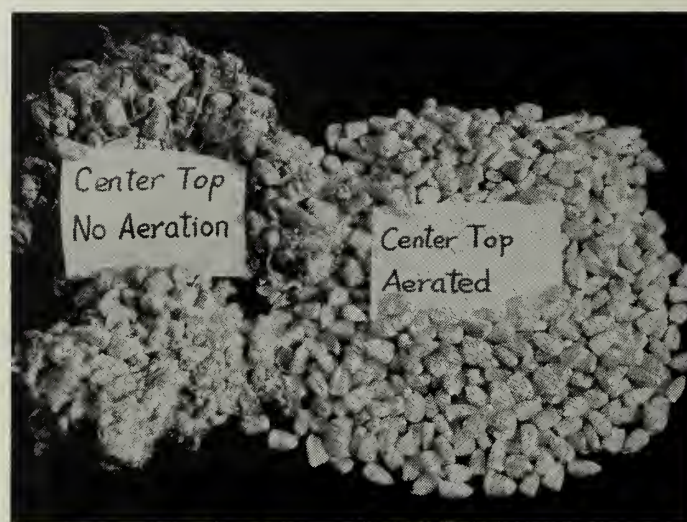
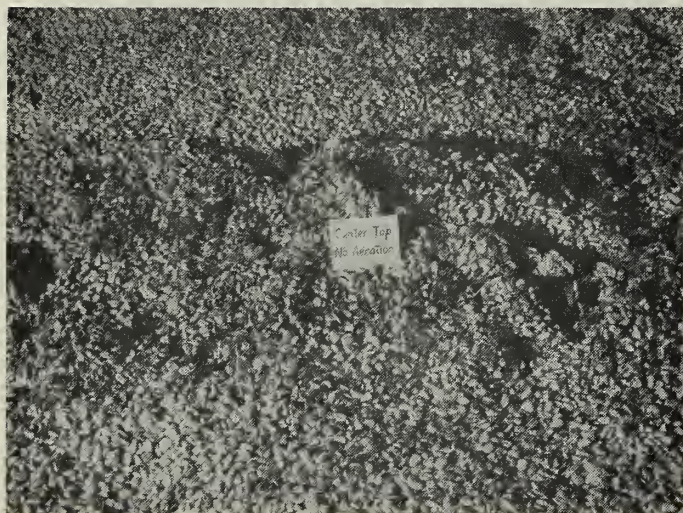
N-25768--These two samples of corn came from adjoining bins. In one, there was no flow of air through the grain; moisture accumulated near the center at the top of the bin, and mold developed in the grain. In the other bin, a fan and duct system aerated the grain, and no mold damage appeared.

N-25769--Moldy corn on top of a bin that had no aeration. The corn averaged 14 percent moisture. Moisture migrated to top and center and caused damage.

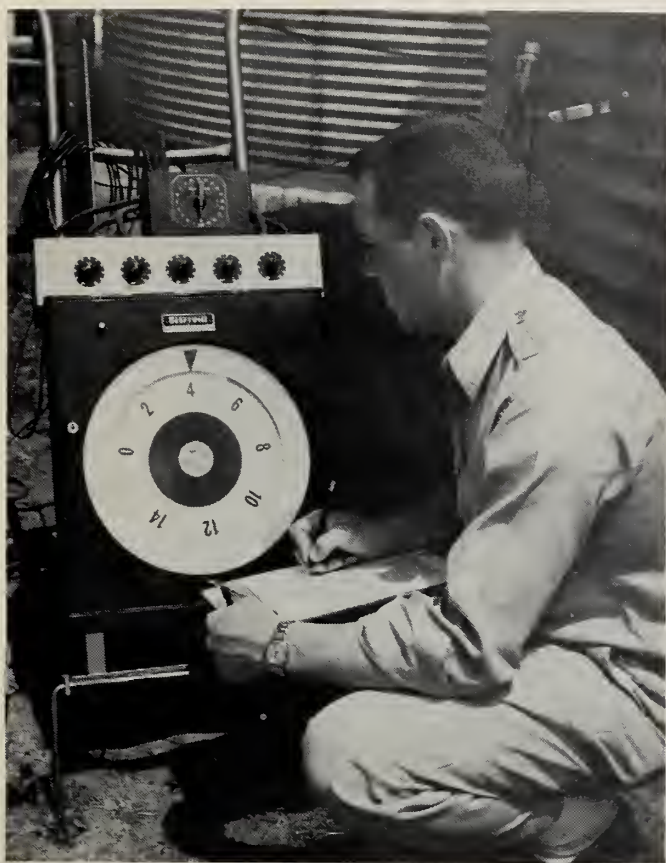
N-25766--Temperature of the corn in 210 bins is taken at regular intervals using this temperature meter and thermocouples. The operator reads the temperatures, one after another for a number of positions in each bin. This reading is 42 degrees, in the bottom, center of the bin.

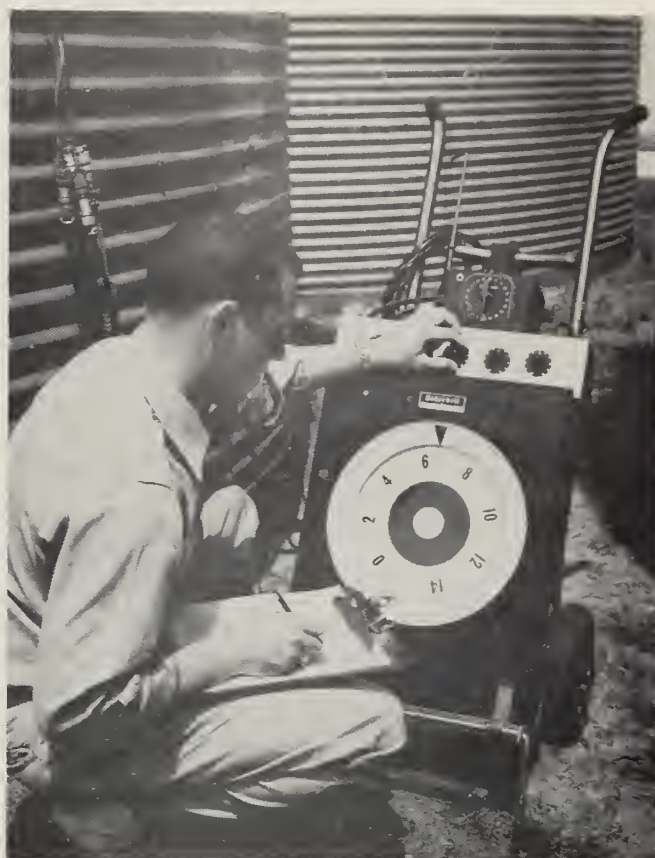
N-25764--The temperature at the top of the corn in the same bin registered 66 degrees, 24 degrees warmer than at the bottom. If mold or insect damage should appear at any time, temperature might be identified as one of the causes.

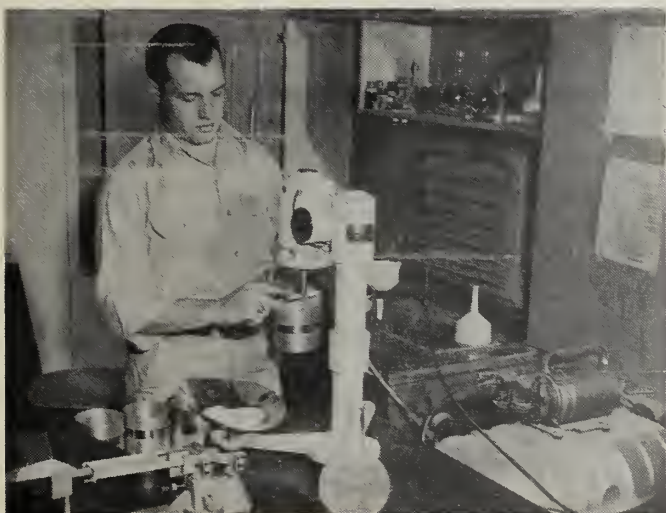
N-25770--The first step in testing corn to determine its content of fatty acids. A sample of corn is ground in this electric grinder and weighed. The vacuum pump at the lower right speeds the action of chemical solvent which extracts the fatty acid.

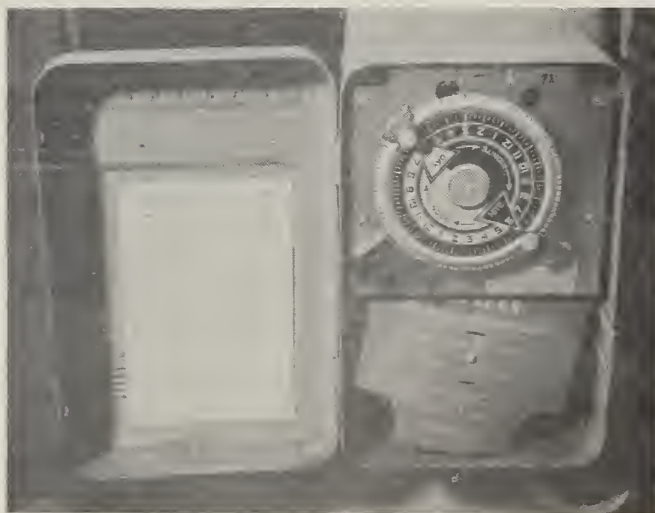
N-25767--This is a time switch, used to turn fans on and off at certain hours. Some of the studies of corn storage are aimed at finding out what happens when grain has air drawn through it at different times of day.

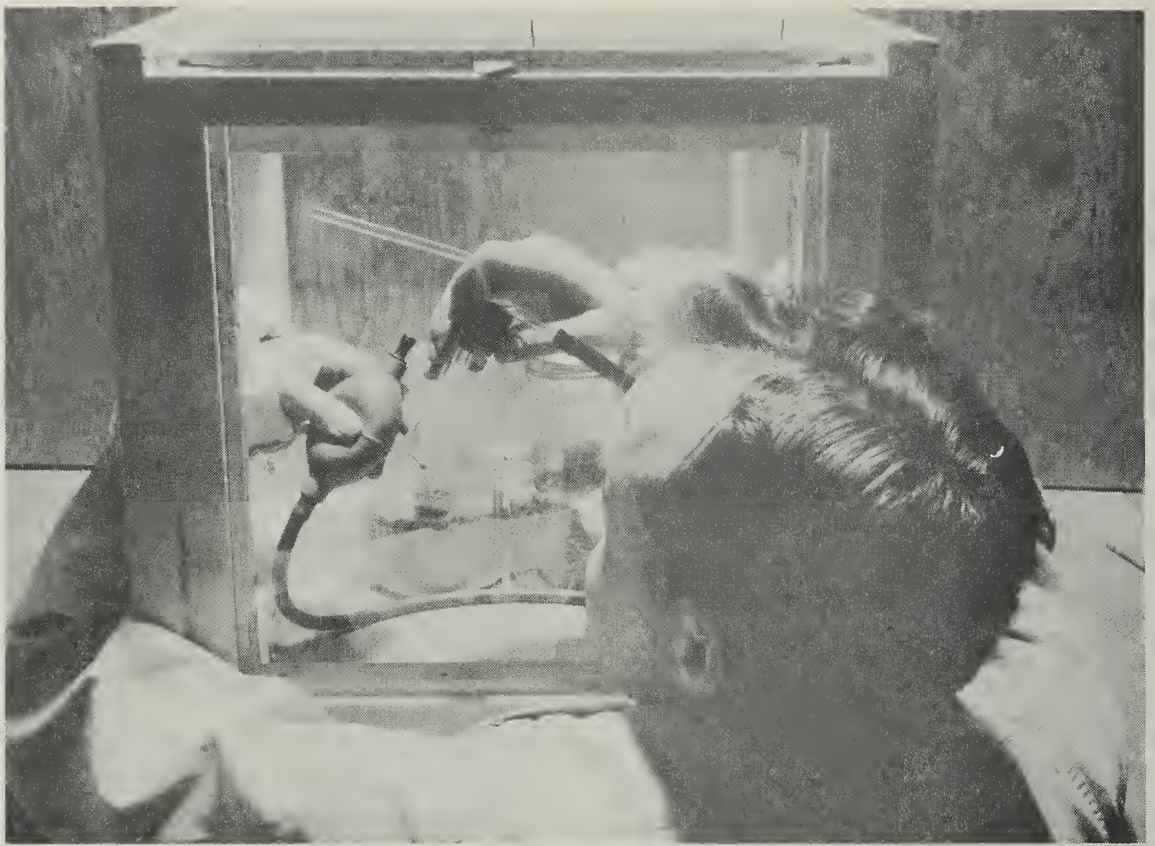
N-25773--How to catch a moth. Project entomologist James Quinlan rears grain insects of several kinds, in glass jars containing bran or corn meal, and "plants" them in certain bins to insure infestation. The bulb in his left hand is used to suck the moth through the glass tube into the bottle in his right hand.

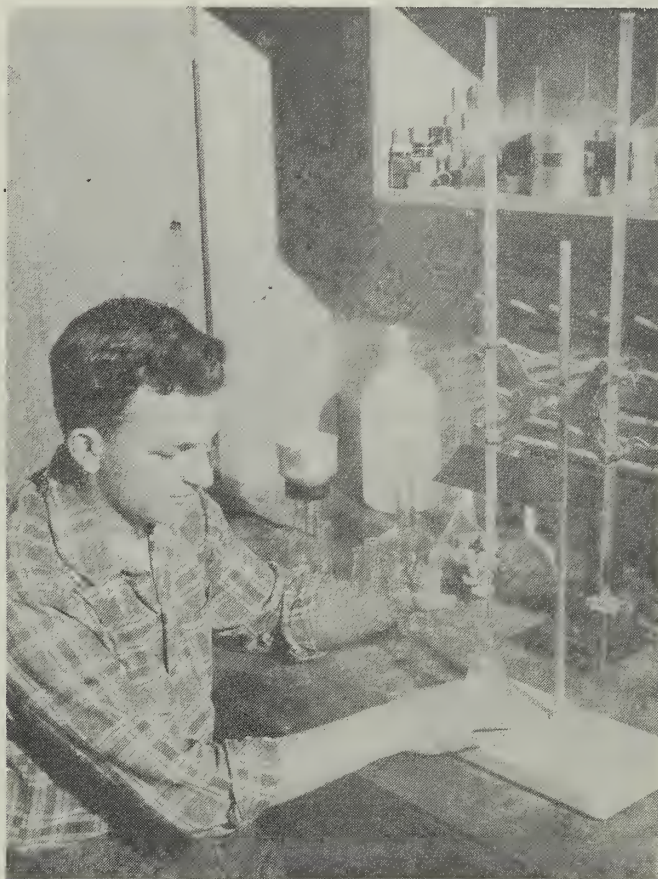
N-25771--Here, a technician measures the amount of fatty acid that has been extracted from a sample of corn. It is believed the development of fatty acid in corn may be a warning that the grain is going out of condition.
